# StorNext 6.x Artico Archive Gateway Release Notes

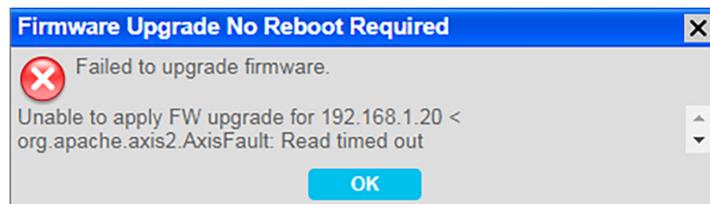
After the **Apply** button is clicked during a firmware upgrade on the StorNext GUI, there are certain instances where the firmware upgrade will fail to complete, and server node 2 may be upgraded, but node 1 will fail to upgrade causing a mismatch of StorNext releases between the nodes. When this happens, the **Firmware Upgrade** page in StorNext, an error message similar to the following may display when the firmware upgrade is being applied:

**i Note:** This issue was fixed in the upgrade code for StorNext 6.1.0. See [Fixed Issues, Notes, and Enhancements – StorNext 6.x on page 5](#) in the "Fixed Issues" section. Upgrade recommended.

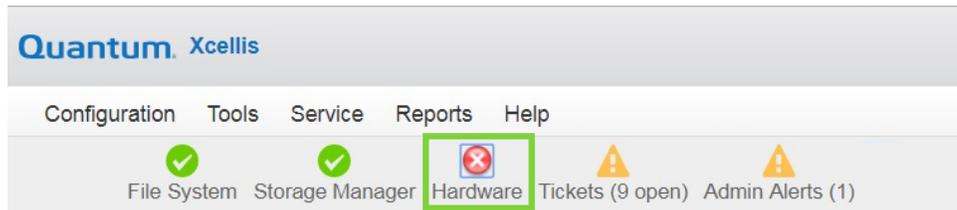
69189      n/a      **Issue:**  
 After upgrading to StorNext 6.0–6.0.1.1, node 2 may report a hardware failure in the StorNext GUI:

When clicked, this hardware failure displays multiple fan failures on the **System Board** tab of the **Reports > Hardware Status** in the StorNext GUI:

**Note:** This issue has been fixed in StorNext 6.0.5. See [69506 on page 16](#) in the "Fixed Issues" section. Upgrade recommended.
