StorNext 6.x M440 Metadata Appliance Release Notes

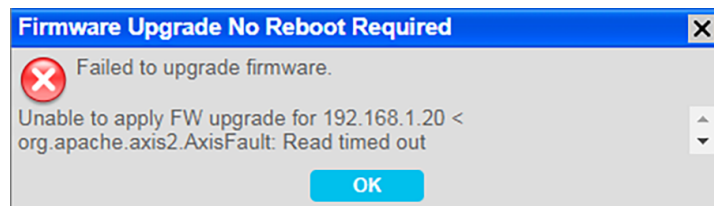
71644

After the **Apply** button is clicked during a firmware upgrade on the StorNext GUI, there are certain instances where the firmware upgrade will fail to complete, and server node 2 may be upgraded, but node 1 will fail to upgrade causing a mismatch of StorNext releases between the nodes. When this happens, the **Firmware Upgrade** page in StorNext, an error message similar to the following may display when the firmware upgrade is being applied:

i Note: This issue was fixed in the upgrade code for StorNext 6.1.0. See [Fixed Issues, Notes, and Enhancements – StorNext 6.x on page 5](#) in the "Fixed Issues" section. Upgrade recommended.

Workaround:
