StorNext 6.x aiWARE for Xcellis Release Notes

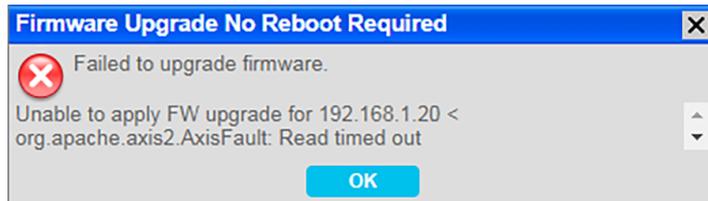
Issue:

After the **Apply** button is clicked during a firmware upgrade on the StorNext GUI, there are certain instances where the firmware upgrade will fail to complete, and server node 2 may be upgraded, but node 1 will fail to upgrade causing a mismatch of StorNext releases between the nodes. When this happens, the **Firmware Upgrade** page in StorNext, an error message similar to the following may display when the firmware upgrade is being applied:

i Note: This issue was fixed in the upgrade code for StorNext 6.1.0. See [Fixed Issues, Notes, and Enhancements – StorNext 6.x on page 6](#) in the "Fixed Issues" section. Upgrade recommended.

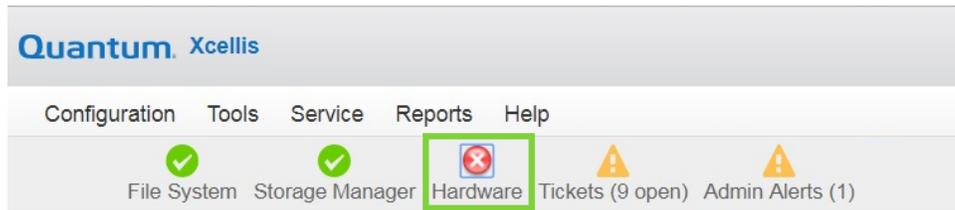
69189 n/a **Issue:**
 After upgrading to StorNext 6.0–6.0.1.1, node 2 may report a hardware failure in the StorNext GUI:

When clicked, this hardware failure displays multiple fan failures on the **System Board** tab of the **Reports > Hardware Status** in the StorNext GUI:

Note: This issue has been fixed in StorNext 6.0.5. See [69506 on page 18](#) in the "Fixed Issues" section. Upgrade recommended.
