QXS Gx222xxxx Release Notes

Date	August 2017

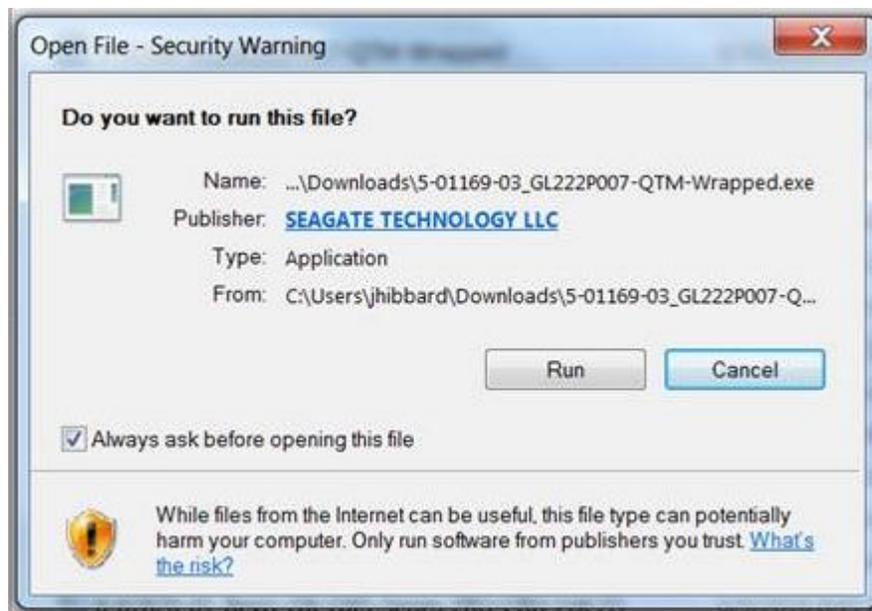
Figure 1 Security Warning
Pop-Up

Refer to [Figure 2](#) for a representative example of the security warning pop-up.

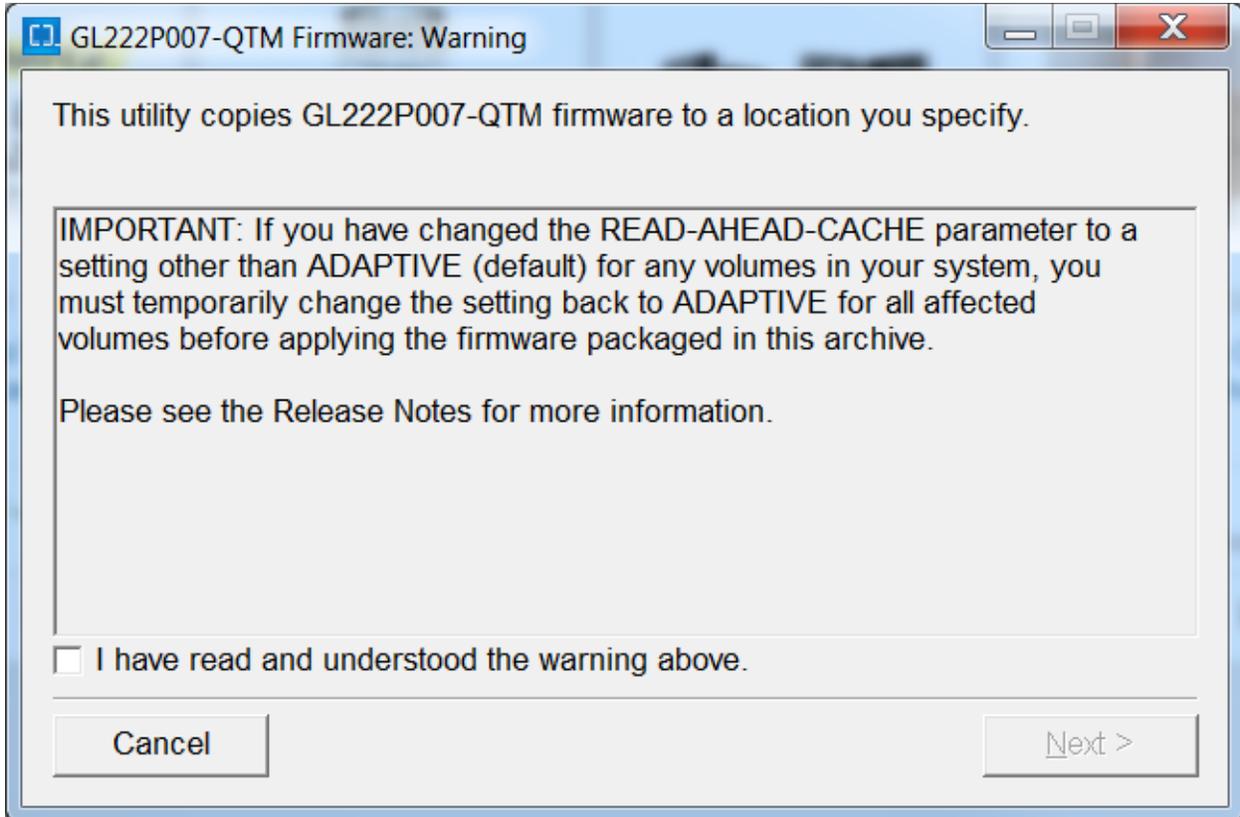
Figure 2 Warning Message

The G222 binaries have been wrapped and a warning message displays to help convey the importance of making this setting change prior to the firmware update.

Refer to [Figure 2](#) for a representative example of the GL222xxxx-QTM Firmware: Warning message.

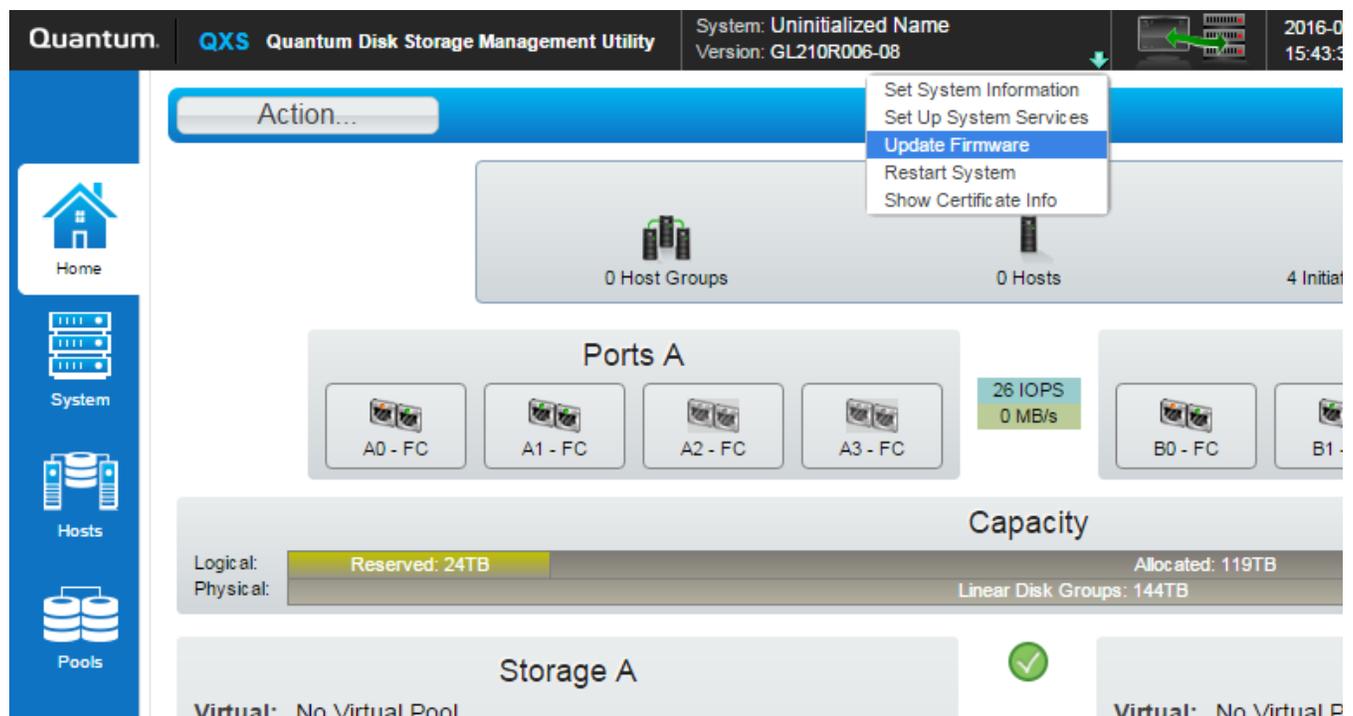
Figure 3 Sample Home Screen

- 1 Obtain the firmware package, and save it to a temporary directory. This firmware release can be obtained by contacting Quantum Technical Support.
- 2 Locate the firmware file in the downloaded/extracted folder. The firmware filename is in the following format: GxxxRyyy-zz.bin.
- 3 In single-domain environments, stop all I/O to vdisks in the enclosure before starting the firmware update.
- 4 Log in to Disk Storage Management Utility.
- 5 Go to the Update Firmware option. There are two ways to do this:
 - a On the top of the home screen (Figure 3), click the first arrow on the upper right where the System name and Version are shown. Click Update Firmware.

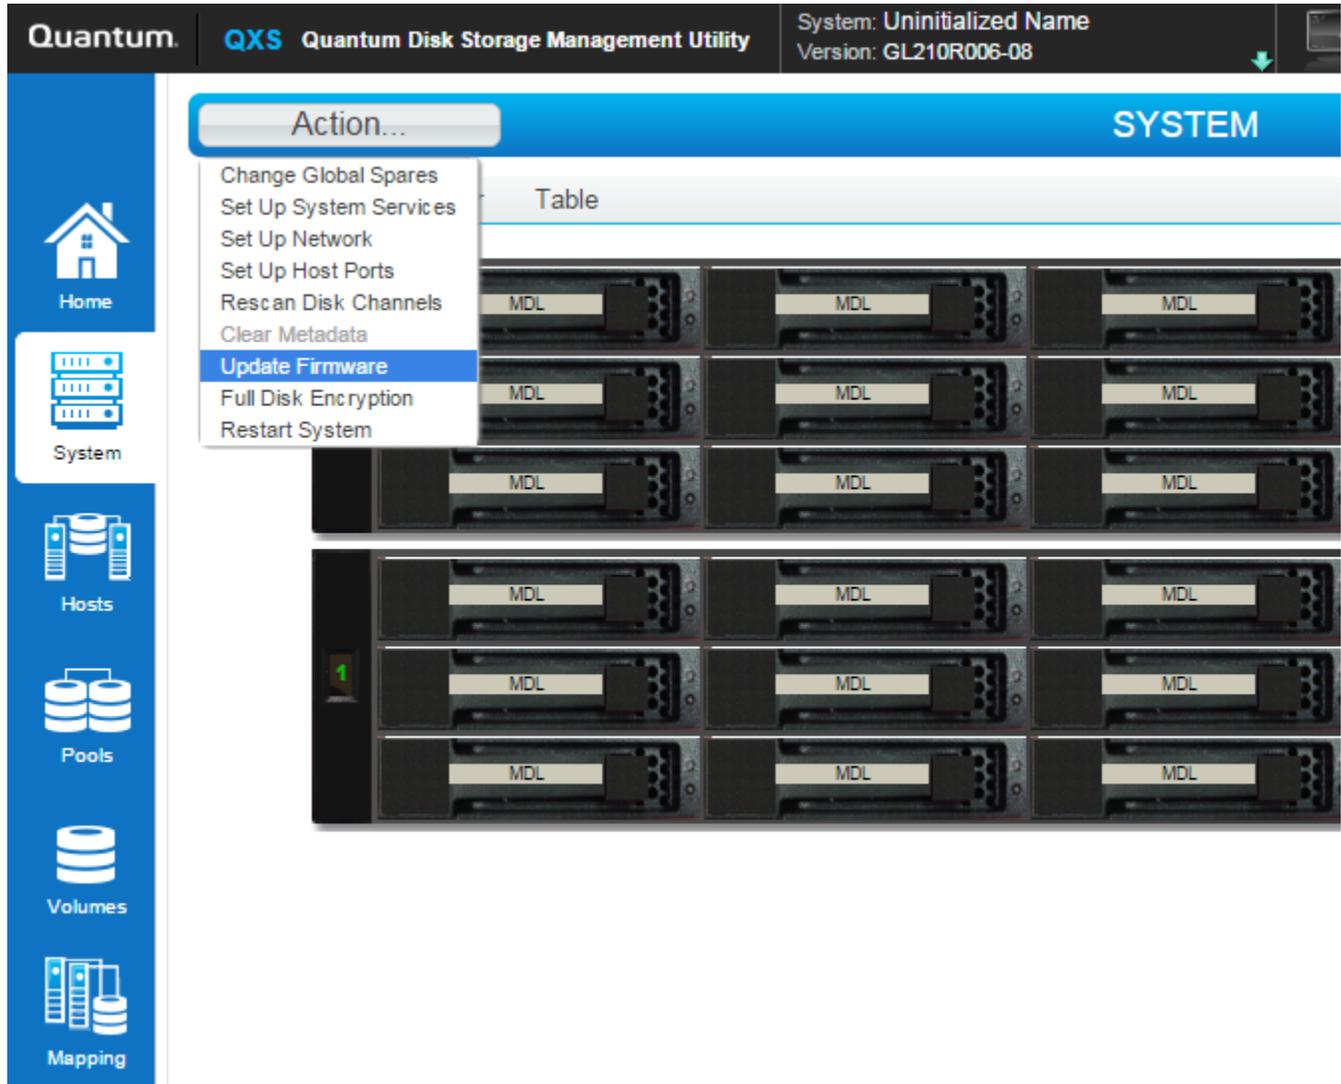
Figure 4 Sample System Screen

- b Click the System tab on the left navigation panel (Figure 4), click the Action button at the top of the system panel, and click Update Firmware.

Note: With either of these methods, the panel displayed contains a table that shows the currently installed firmware versions.
