QXS Gx222xxxx Release Notes

Product	The Gx222xxxx firmware includes the following versions:
	<ul style="list-style-type: none">• GL222R070 for:<ul style="list-style-type: none">• QXS-312 and QXS-324• QXS-412, QXS-424, QXS-448, and QXS-456• StorNext QXS-1200, QXS-2400, and QXS-5600• DH-3534, DH-3524, DH-3834, and DH-3824• DH-4534, DH-4524, DH-4544, DH-4554, DH-4834, DH-4824, DH-4844, and DH-4854• GF222R070 for:<ul style="list-style-type: none">• QXS-648 and QXS-656• DH-6544, DH-6554, DH-6844, and DH-6854

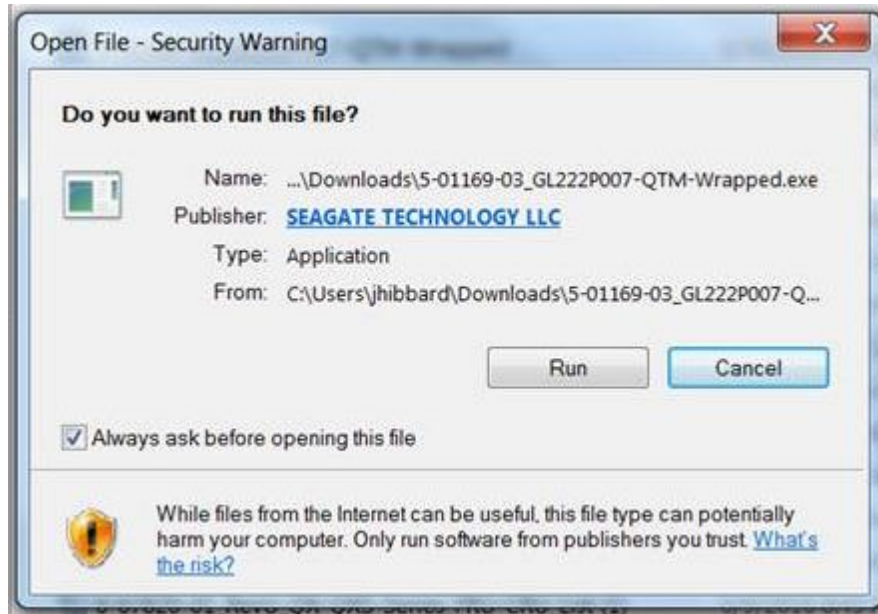
Figure 1 Security Warning Pop-Up

Refer to [Figure 2](#) for a representative example of the security warning pop-up.

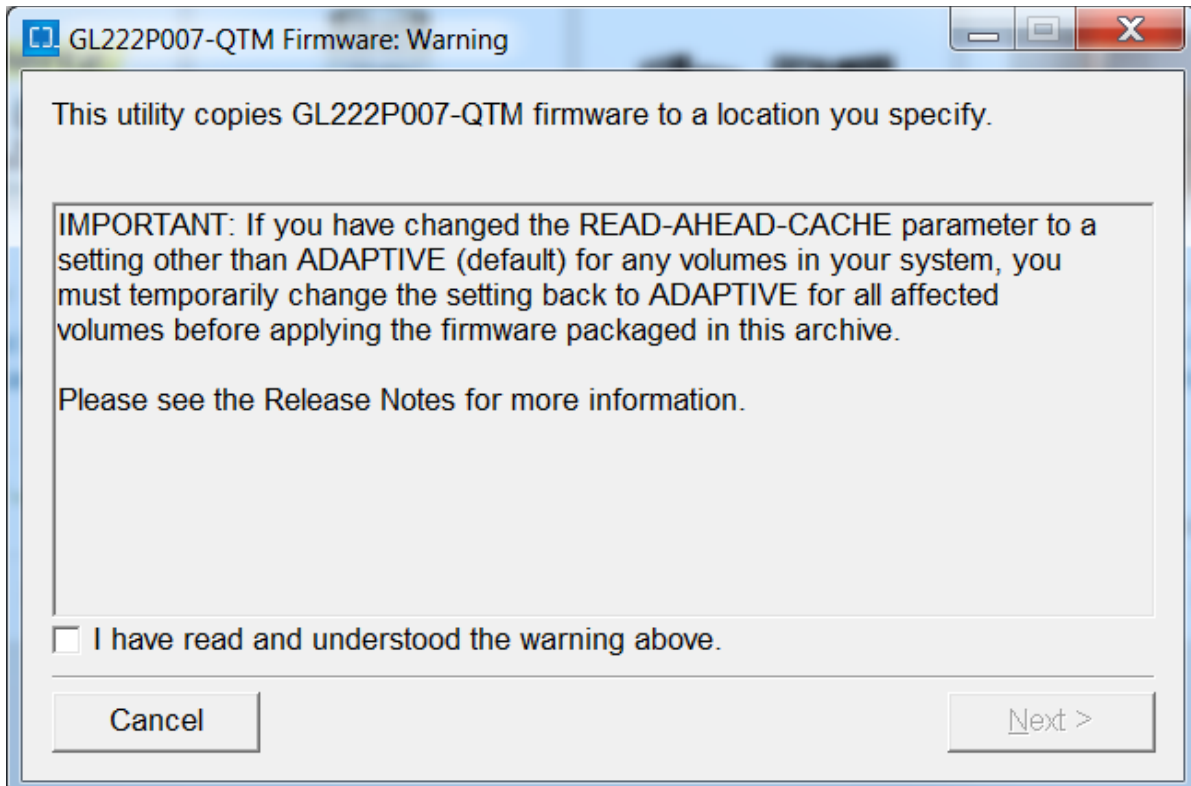
Figure 2 Warning Message

Refer to [Figure 2](#) for a representative example of the GL222xxxx-QTM Firmware: Warning message.

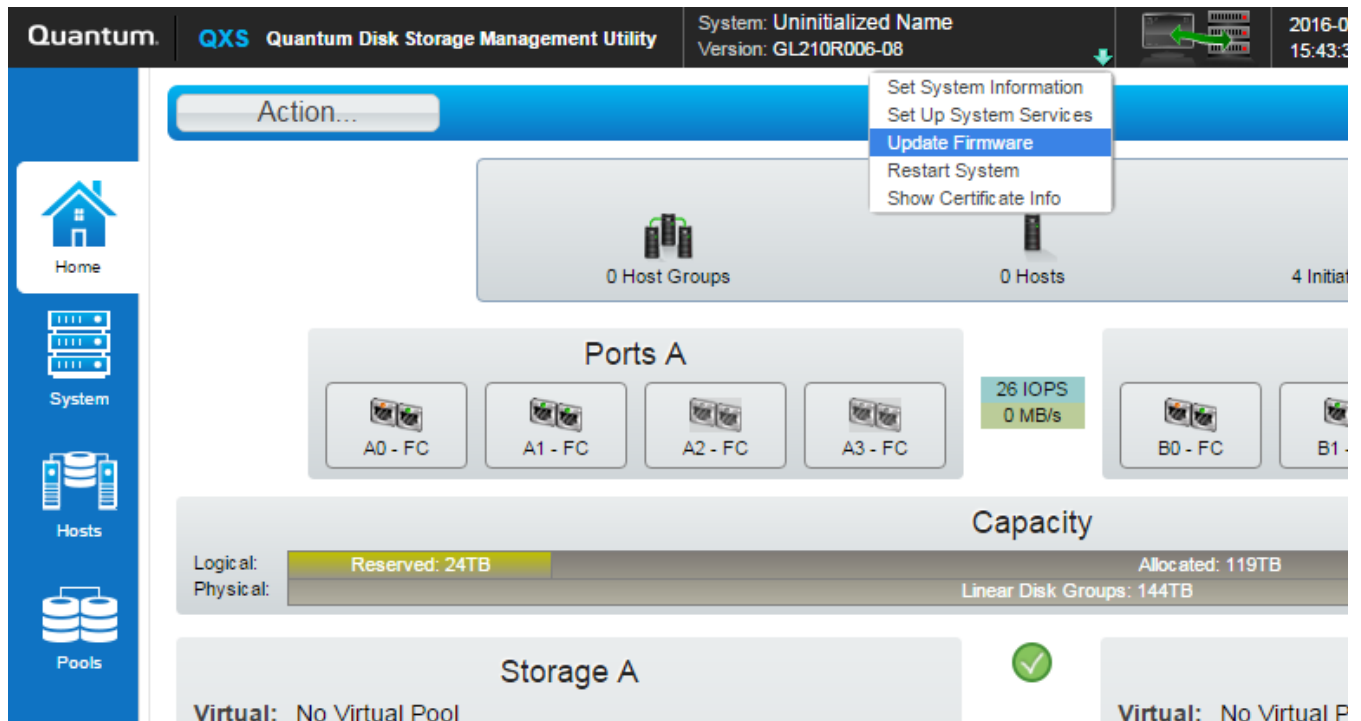
Figure 3 Sample Home Screen

- 1 Obtain the firmware package, and save it to a temporary directory. This firmware release can be obtained by contacting Quantum Technical Support.
- 2 Locate the firmware file in the downloaded/extracted folder. The firmware filename is in the following format: GxxxRyyy-zz.bin.
- 3 In single-domain environments, stop all I/O to vdisks in the enclosure before starting the firmware update.
- 4 Log in to Disk Storage Management Utility.
- 5 Go to the Update Firmware option. There are two ways to do this:
 - a On the top of the home screen (Figure 3), click the first arrow on the upper right where the System name and Version are shown. Click Update Firmware.

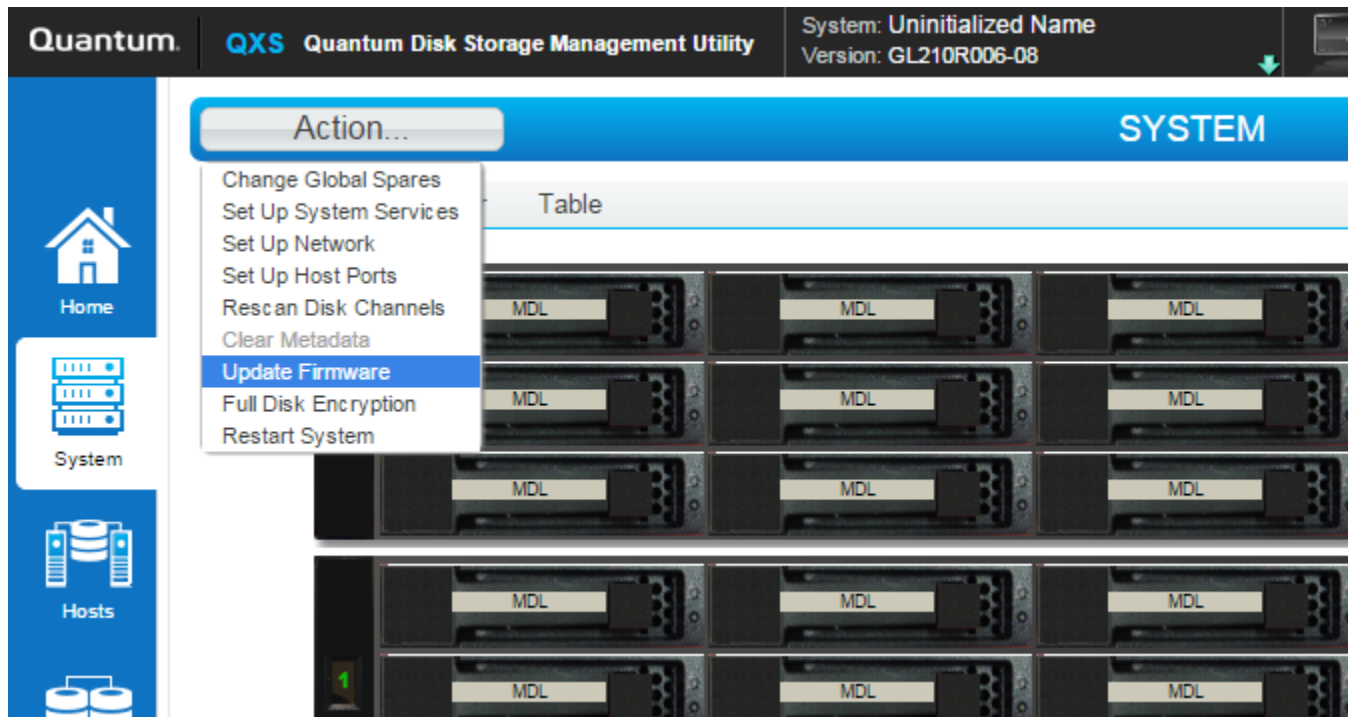
Figure 4 Sample System Screen

- b Click the System tab on the left navigation panel (Figure 4), click the Action button at the top of the system panel, and click Update Firmware.

Note: With either of these methods, the panel displayed contains a table that shows the currently installed firmware versions.
