QXS 12G (Gen1) G2xxxxxx Release Notes

Supported QXS Firmware Releases, Products, Operating Systems, and Storage Configurations

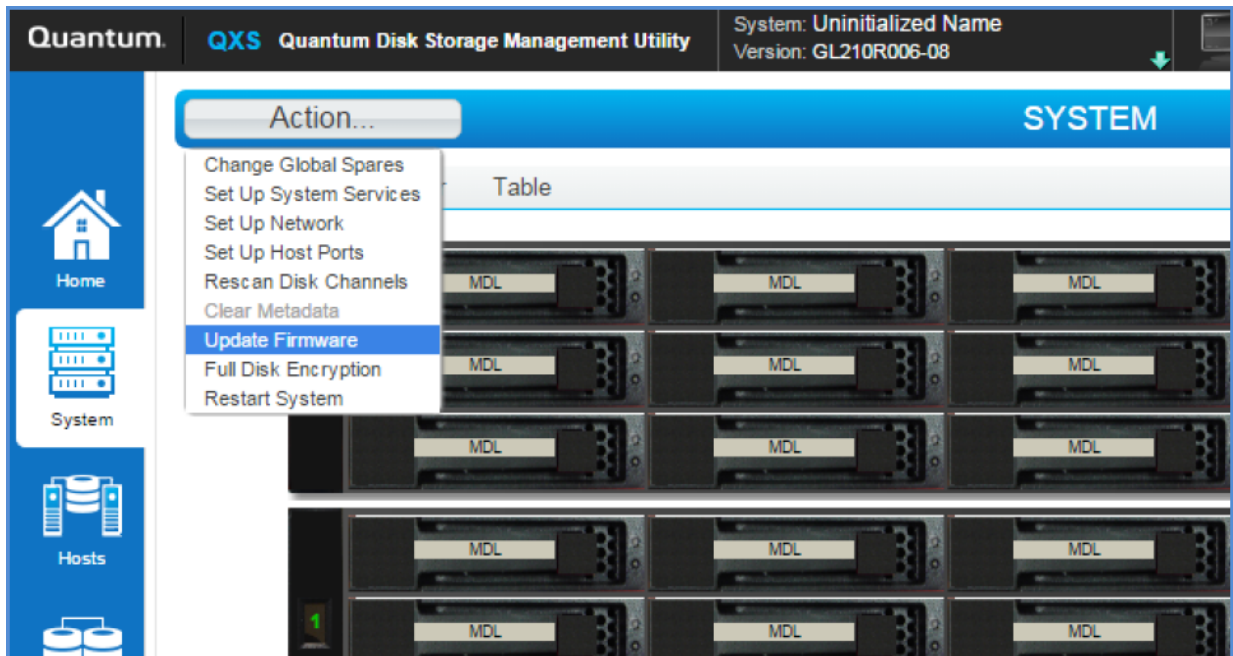
- b. Click the **System** tab on the left navigation panel (Figure 2), click the **Action** button at the top of

the system panel, and click **Update Firmware**:

i Note: With either of these methods, the panel displayed contains a table that shows the currently installed firmware versions.
